# FEEDBACK

【 航空安全情報自発報告制度（VOICES）共有情報 】 一部英訳版

No. 2025-02

Dec.24<sup>th</sup>, 2025

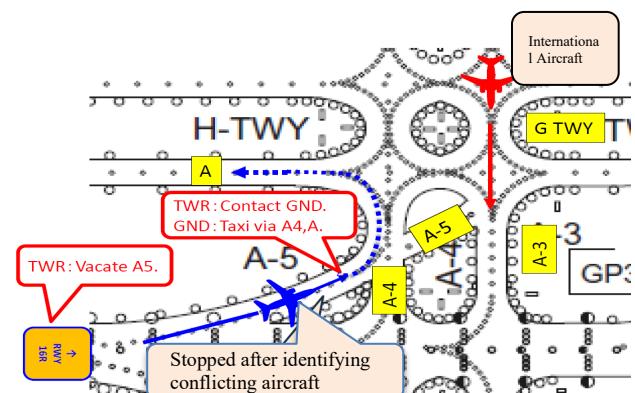
(FEEDBACK No.2025-02-69)

We planned to vacate RWY 16R via A5 at Haneda Airport and landed accordingly. During the landing roll, the only instruction we received was “Vacate A5.” As we attempted to exit at A5, the PIC in the left seat (PM) identified an international aircraft on Taxiway G proceeding at high speed toward A3. We brought our aircraft to a complete stop near the A5 hold-short line (👉).

Subsequently, ATC instructed us to “Contact Ground,” and Ground Control then issued “A4, A.” Had we continued straight through A5 based solely on the initial instruction, there would have been a very high risk of a head-on conflict with the aircraft on Taxiway G. From a safety standpoint, it would have been preferable for ATC to provide an instruction such as “A5, then A4,” or alternatively to hold the traffic on G at W to ensure safer taxi flow.
