# FEEDBACK

【 航空安全情報自発報告制度（**VOICES**）共有情報 】

No. 2026 – 01

Aug.21st, 2026

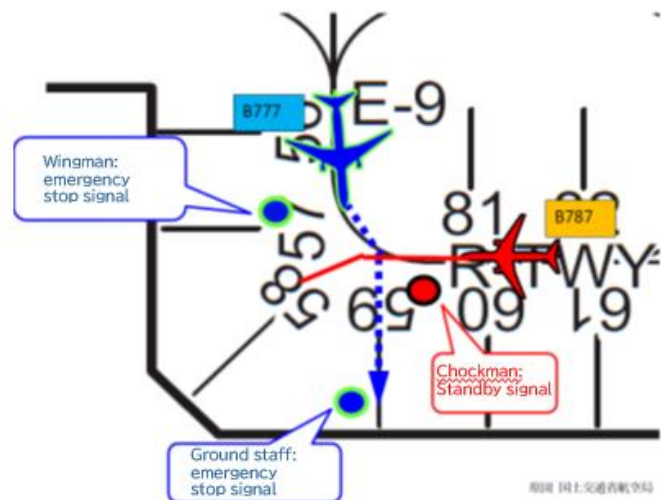
## 28. *You'll get sucked into the engine!*

While taxiing our B777-300 into Spot 59 at Haneda Airport from E9, a B787-8 at Spot 58 had just finished

pushback facing North on R, and the Tow Bar was about to be disconnected. The clearance with the B787 was slightly tight, but there was no issue. As we approached the parking spot, I could confirm the Wingman on the right side ahead of us, and confirmed the hand signal indicating no obstacles. The VDGS was also functioning as normal. I could also see another ground staff member standing further back at Spot 59. Looking to the left side, our Wingman was not there, but the Chockman handling the B787's Pushback was giving a standby signal toward the B787 from the normal position 45 degrees in front, and another ground staff member (Headset Operator) was about to move away from the B787's Nose. However, the position where this Chockman was standing giving the standby signal was clearly on the near side of the row of containers at Spot 59, and it appeared to us that he was in a position where he could be sucked into our left engine, so we slowed down (👍). The Chockman was looking toward the B787 and did not seem to notice our approach. At almost the same moment our aircraft stopped, the Wingman on the right side also switched to an emergency stop signal, and the ground staff further back also gave an emergency stop signal. I wonder if it was because we slowed down that they noticed. As far as I recall, the VDGS had not changed. After that, the Chockman evacuated along with the ground staff member who had moved away from the B787's Nose, and the Wingman's hand signal returned to indicating no obstacles, and we completed Block In as normal. Note that after Block In, we were unable to communicate due to an interphone malfunction, and we were only able to speak after deplaning was complete. I verbally requested that this event be shared in order to prevent recurrence. Perhaps because it was daytime with good weather and I was looking for the Wingman, I was able to notice the abnormality (👍). However, if this had occurred at night with rain falling, we might have also had the Taxi Lights off and might not have noticed. In that case, who would have been able to notice the danger approaching the Chockman... It was a frightening moment.

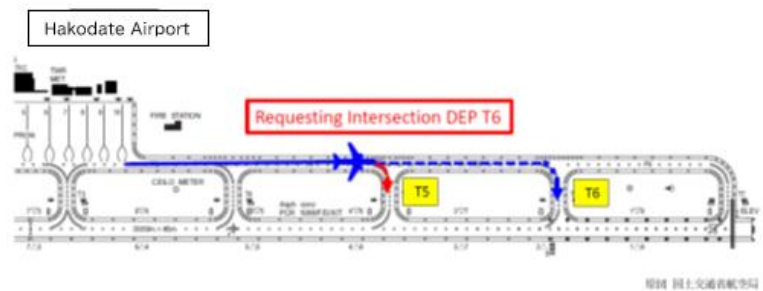
### 33. Intersection Misidentification During Departure

During departure from Hakodate Airport, we requested an intersection departure from T6, but mistakenly entered T5 instead. Possible contributing factors include the fact that T5 already felt sufficiently far down the 3,000m runway, the slope of the taxiway, and our preoccupation with recovering from a delay. I also believe that, as PM, my reduced vigilance regarding the PF's turn intention meant that my monitoring function was not working at all. On this occasion, the controller pointed out that our current position was T5 (👍), so we stopped short of the runway, recalculated the takeoff performance, and then took off. It is frightening to think what might have happened had we taken off using the T6 takeoff performance data without receiving that call-out. We were saved by TWR. For reference, I would also mention Nagasaki Airport as another airport where a similar error could easily occur, given its long runway and a ramp area located near the end of the runway/field.

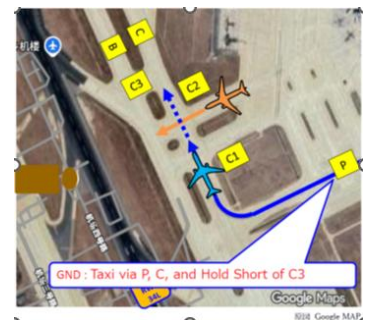
### 45. Air traffic control instruction error during TAXI

After landing on TSN (RWY 16L), we received taxi clearance: Our taxi via P C and hold short of C3. But approaching C2, we recognized one A/C coming from right (on C2) any going to B, so conflicting with our taxiing. So, we stopped taxiing (even according to ATC clearance, we was supposed to be No.1 on taxi) and make the A/C pass in front of us. We request ATC about information of happening and they apologize about their mistake (ATC mistake was they instruct us to hold C3 instead of C2)

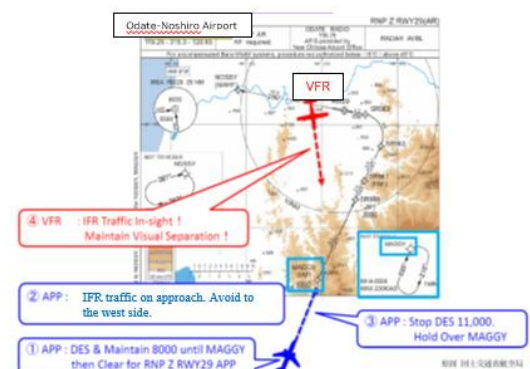
### 72. VFR Traffic Approaching During Descent

Suddenly, a VFR aircraft appeared, climbing toward MAGGY and continued to climb even after passing 6,000 ft.

Shirakami Approach called out to the VFR aircraft repeatedly, but they didn't respond. The aircraft was still climbing past 8,000 ft. We considered turning toward NOSSY, but heading directly toward it would prolong a head-on situation, and we didn't know how high the aircraft would climb.

However, holding at MAGGY requires a right turn. While we were considering this option:

ATC instructed us, "Stop descent, maintain 11,000 ft, hold over MAGGY." Shortly after we turned south: VFR Aircraft: "IFR traffic in sight. Maintain visual separation."

Wait a second—the ones who actually ensured separation were Shirakami Approach and us! We failed to identify this oncoming VFR threat beforehand, resulting in an ad-hoc, reactive response.
